# PAVEMENTS AND STUDED TIRE DAMAGE

## WSDOT - State Materials Laboratory

### **UPDATE: December 2008**

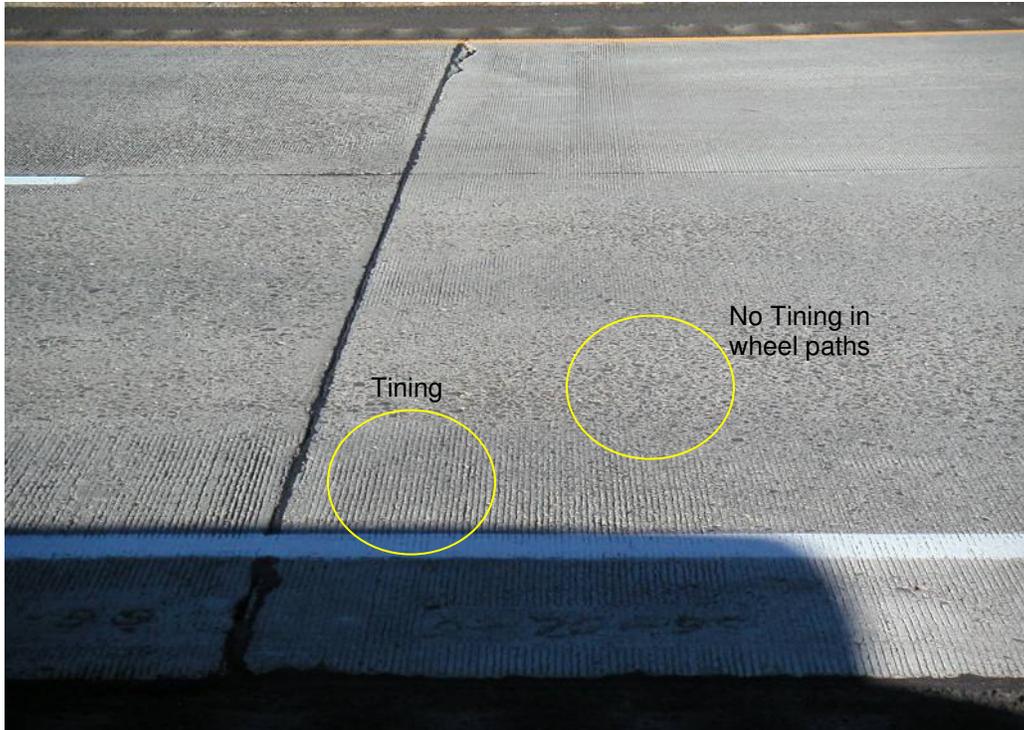
Eight year old concrete pavement, Washington State: Photo 3 shows a concrete pavement constructed in 1995 on state route (SR) 395 in the vicinity of Ritzville, just south of Interstate (I) 90. At the time of this photo, this pavement had been in service for eight years (photo taken in 2003). The current average annual daily traffic on this route is approximately 6,800 vehicles. This pavement had a surface treatment that is referred to as “transverse tining,” Transverse tining is created by pulling a rake across the wet concrete which forms shallow grooves on the surface, similar to the texture of corduroy (Photo 4). These shallow grooves, or tining, increase the pavement skid resistance. Photo 3 shows that the tining has been completely removed from the wheel paths, due to studded tires, while the tining outside of the wheel path is intact at the edges of the pavement.

Photo 3. Concrete pavement on SR-395 south of I-90.  
 ADT: 6,800 vehicles  
 Pavement age: Eight years

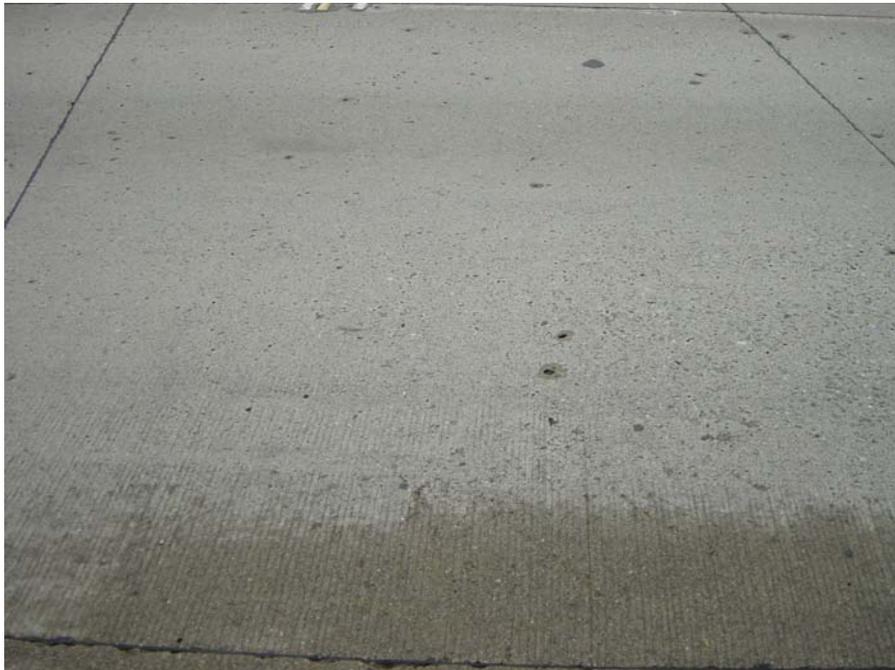
16 year old concrete pavement, Washington: Photo 6 shows a 16 year old concrete pavement constructed in 1989 on I-90 in Seattle in the vicinity of Rainier Avenue (photo taken in 2005). This pavement has an average annual daily traffic of 120,000 vehicles.

Photo 6. Concrete pavement on I-90 in Seattle (Rainier Avenue).  
ADT: 120,000 vehicles  
Pavement Age: 16 years

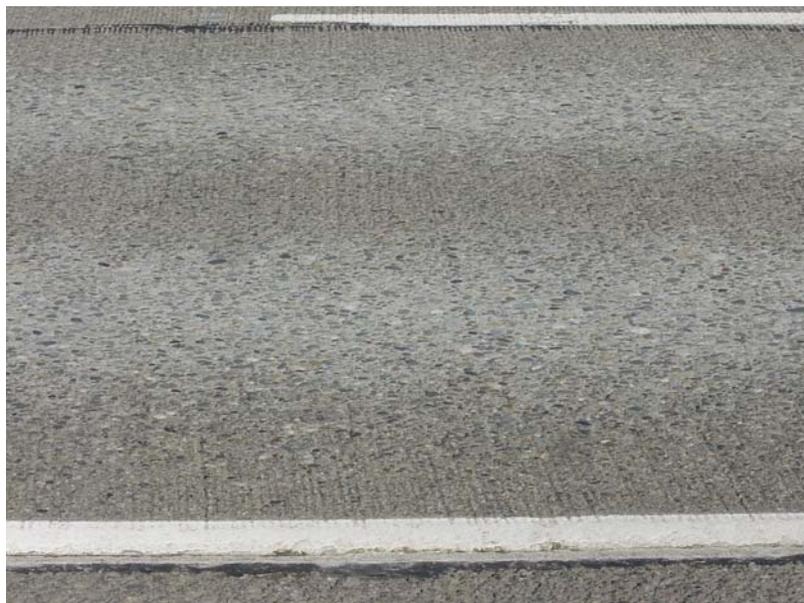
28 year old concrete pavement, Washington: Photo 8 shows a 28 year old concrete pavement constructed in 1977 on I-90 near Preston-Fall City. The average annual daily traffic on this section of pavement is 50,000 vehicles.

Photo 8. Concrete pavement on I-90 near Preston Fall City.  
ADT: 50,000 vehicles  
Pavement Age: 28 years

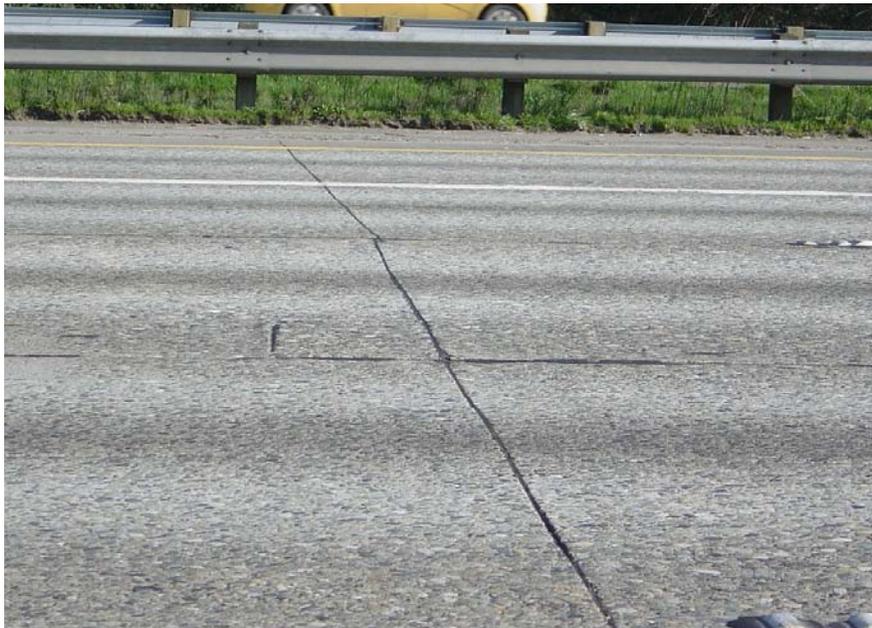
34 year old concrete pavement, Washington: Photo 10 shows a 34 year old concrete pavement constructed in 1967 on I-5 in Seattle in the vicinity of Boeing Field (photo taken 2005). The average annual daily traffic on this section of pavement is 204,000 vehicles.

Photo 10. Concrete pavement on I-5 near Boeing Field.  
ADT: 204,000 vehicles  
Pavement Age: 34 years

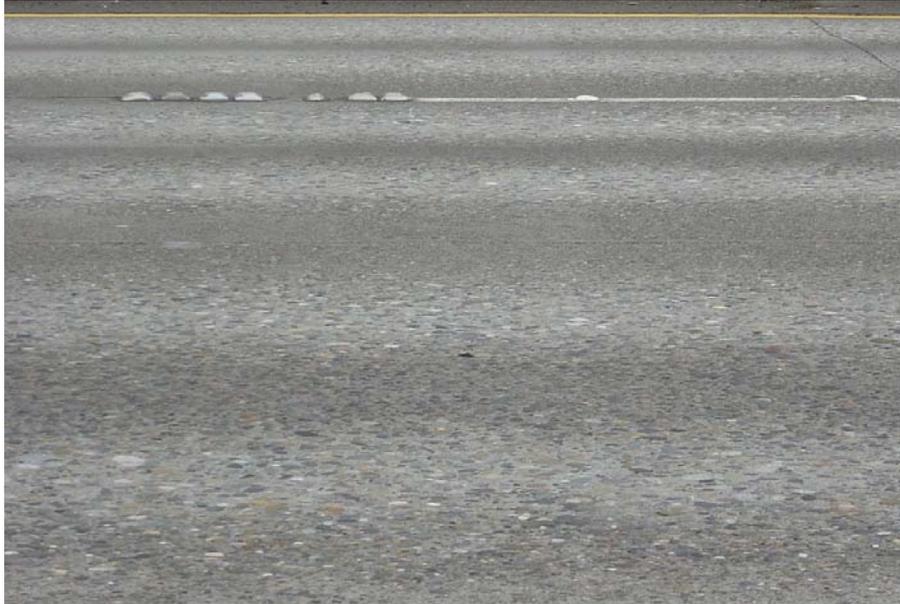
40 old concrete pavement, Washington State: Photo 11 illustrates the concrete pavement surface on I-5, in the vicinity of the Tacoma Dome. WSDOT constructed this pavement 40 years ago, in 1965 (photo taken 2005). This section of I-5 has a current average annual daily traffic of 194,000 vehicles. Studded tires have worn away the top surface of the concrete, exposing the large rock below. The worn areas are lower than the rest of the pavement, forming ruts that tend to pond water, creating safety concerns. Severe ruts must be addressed through pavement rehabilitation. The wear is more prevalent in the wheel paths than at the pavement edges and center of the lane.

Photo 11. Concrete pavement on I-5 near the Tacoma Dome.  
ADT: 194,000 vehicles  
Pavement Age: 40 years

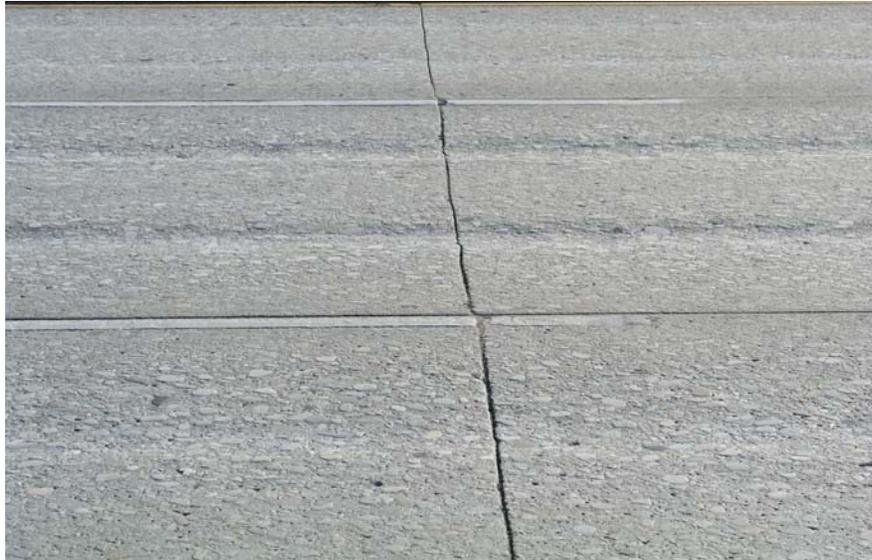
48 year old concrete pavement, Washington State: Photo 12 shows the concrete pavement surface on I-90 in Spokane, vicinity of Altamont Street that was constructed 48 years ago, in 1958. This section of I-90 has an average annual daily traffic of 100,000 vehicles. What is interesting to note on this pavement section is that in 1995 WSDOT conducted a rehabilitation project to diamond grind the existing surface to remove studded tire damage, 11 years later the studded tire wear continues to develop and is visibly noticeable (photo taken 2006). This photo also shows all three lanes on this highway section. The bottom of the photo is the far right lane and the top portion of the photo shows the far left lane. Another characteristic that is typical of studded tire wear is that on multi-lane facilities (3 or more lanes in one direction) the middle lane generally has the most severe studded tire damage (i.e. the location of the majority of the passenger vehicle traffic).

Photo 12. Concrete pavement on I-90 in Spokane.  
 ADT: 100,000 vehicles  
 Pavement Age: 48 years

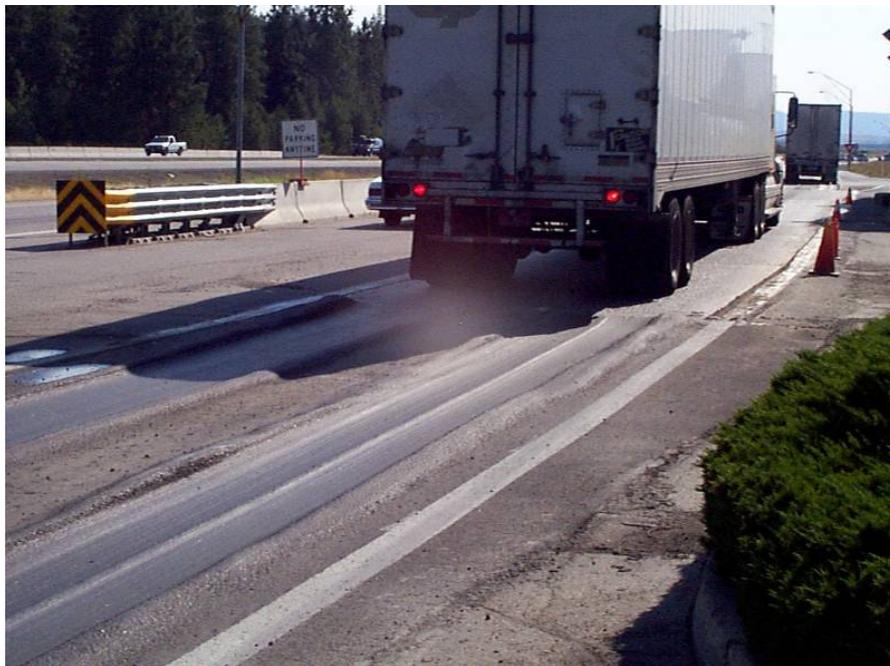
A spectacular, but not typical, hot mix asphalt pavement rutting failure is shown in Photo 13: too much liquid asphalt in this pavement lead to the rapid rutting and shoving seen in the photo. Please note that this is a rare failure on a very small section of a truck weigh scale; the majority of hot mix asphalt pavement rutting is not this severe.

Photo 13. Spectacular, but not typical, hot mix asphalt pavement rutting (I-90 Port of Entry Weigh Scale, Spokane vicinity).

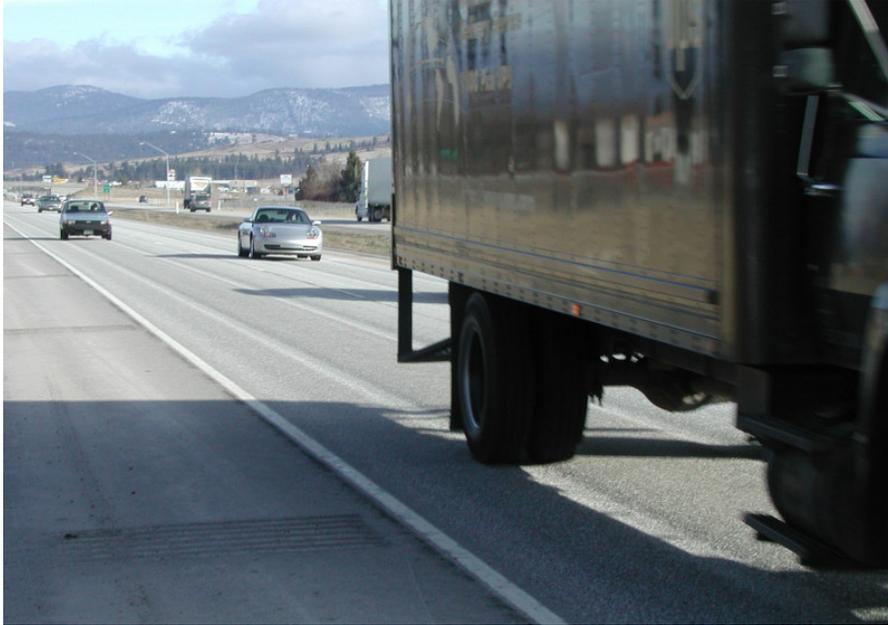
Hot mix asphalt pavement raveling due to studded tires is quite different in appearance (Photo 14). Studs grind the surface of the hot mix asphalt pavement, wearing a groove into the roadway. In Photo 14, note that the dual wheel width of the semi truck exceeds the width of the studded tire groove (or rut), while the car wheels of the vehicle shown in the background lay directly within the wear pattern. The dynamics of studded tire action include three phases; as the studded tire moves over the pavement, there are “spikes” in force at the beginning and at the end of contact. During these spikes, energy is transferred to the pavement in the form of scratching. Between these spikes, the studs have a “punching” action that breaks up aggregate and picks out the pavement surface.

Photo 14. Wear due to studded tires on a hot mix asphalt pavement (I-90 in the vicinity of the Idaho Border).

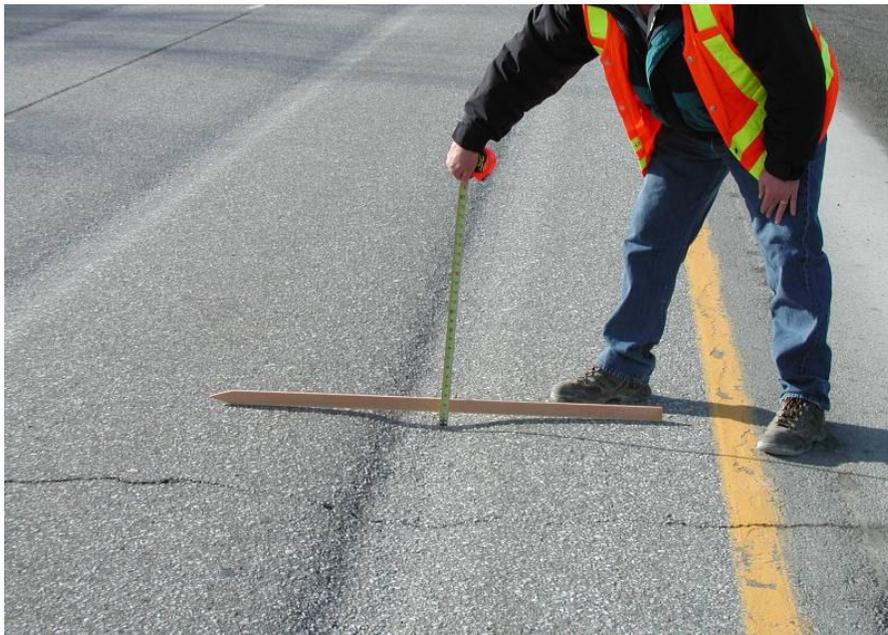
Photo 15 shows a close-up of an open-graded hot mix asphalt pavement that has been damaged by studded tires. This pavement was originally placed in 1992 and was replaced three years later due to the significant rut caused by studded tires (approximately 1-½ inches deep).

Photo 15. Studded tires raveling on hot mix asphalt pavement on I-90 vicinity of Idaho border.

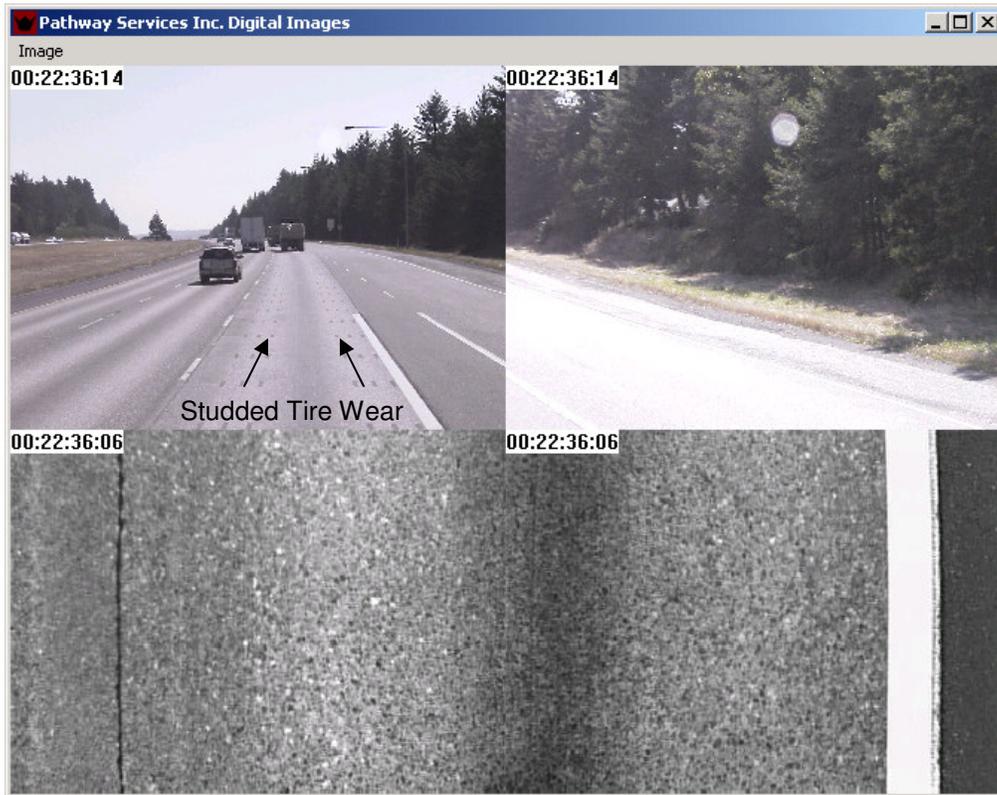
Once the rut measurements are collected, they are analyzed to determine the maximum rut/wear depth, the location of the maximum rut/wear and the width of rut/wear in each wheel path. Figure 2 and Photo 18 show the studded tire wear on a concrete pavement.

Photo 18. Pavement view in location of studded tire wear (I-5, northbound, milepost 112.23, Lacey vicinity, concrete pavement).

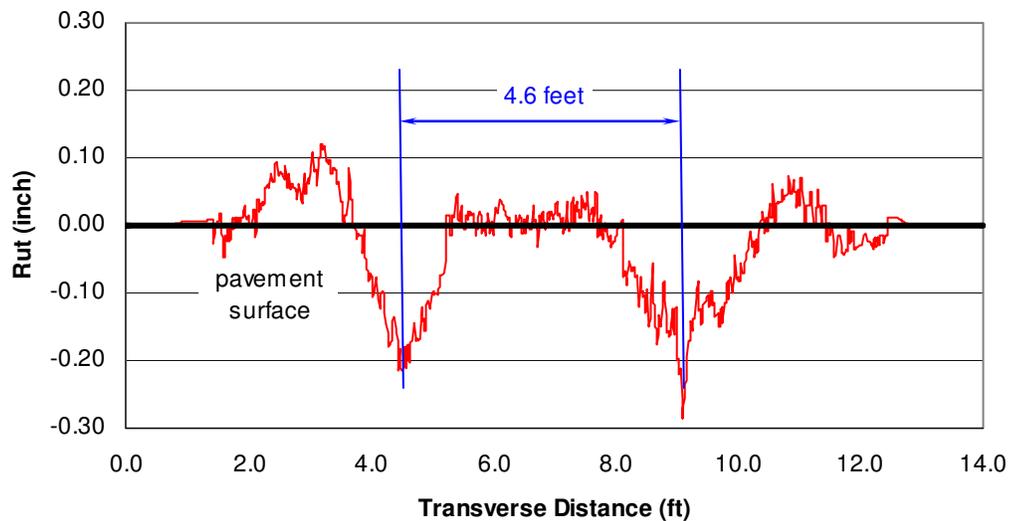
Figure 2. Transverse profile in an area of studded tire wear (I-5, northbound, milepost 112.23, Lacey vicinity, concrete pavement).

entirely due to studded tires and shows a loss of material from the pavement. The example on hot mix asphalt pavement ruts are from shoving (or plastic flow) where the pavement has been physically deformed by heavy truck traffic.

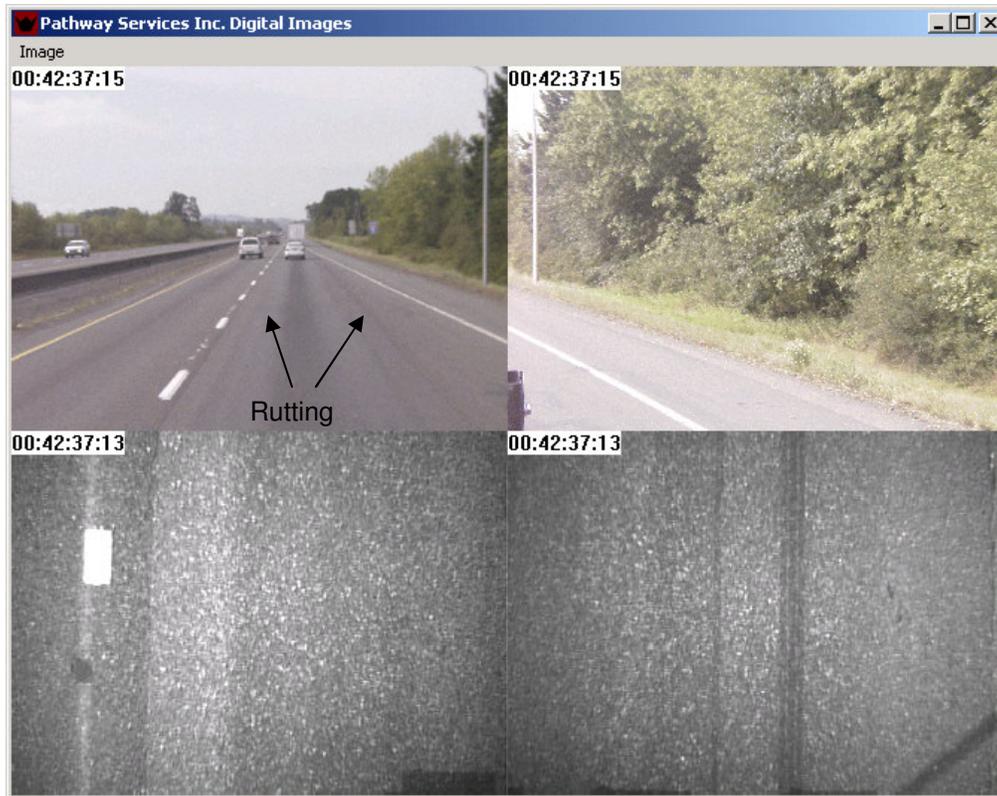
Figure 3 and Photo 19, show rutting on hot mix asphalt pavement.

Photo 19. Pavement view in location of rutting (I-5, southbound, milepost 63.00, Toledo vicinity, hot mix asphalt pavement).

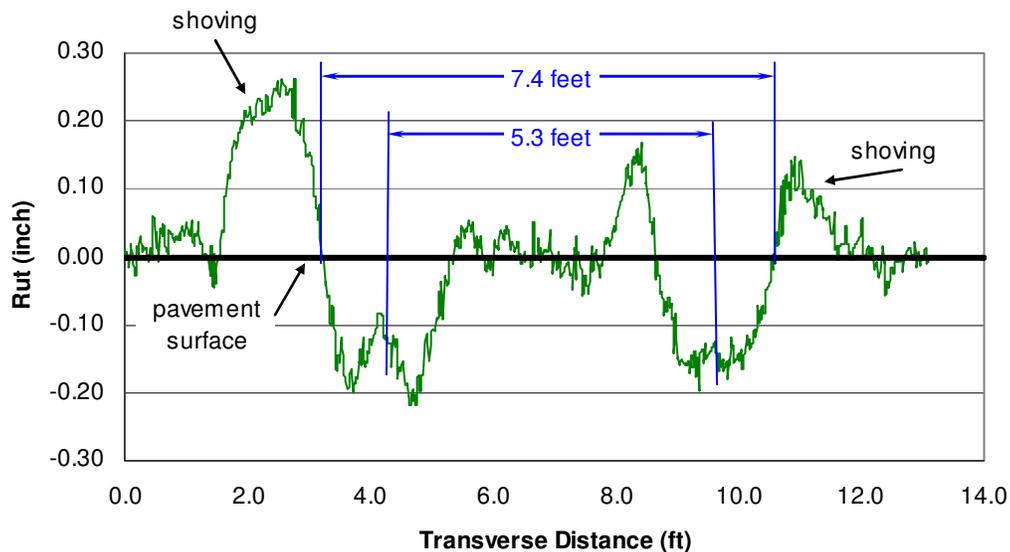
Figure 3. Transverse profile in location of rutting (I-5, southbound, milepost 63.00, Toledo vicinity, hot mix asphalt pavement).
